STRUCTURAL DEFORMATION MONITORING ANALYSIS USING GEODETIC TECHNIQUES AFTER THE EARTHQUAKE AT BOLU PASS OF TRANS-EUROPEAN MOTORWAY

Esra TEKDAL EMNİYETİ, Rahmi Nurhan CELİK and Tevfik AYAN

*Istanbul Technical University, Civil Engineering Faculty, Division of Geodesy, 34469 Maslak
Istanbul, Turkey*

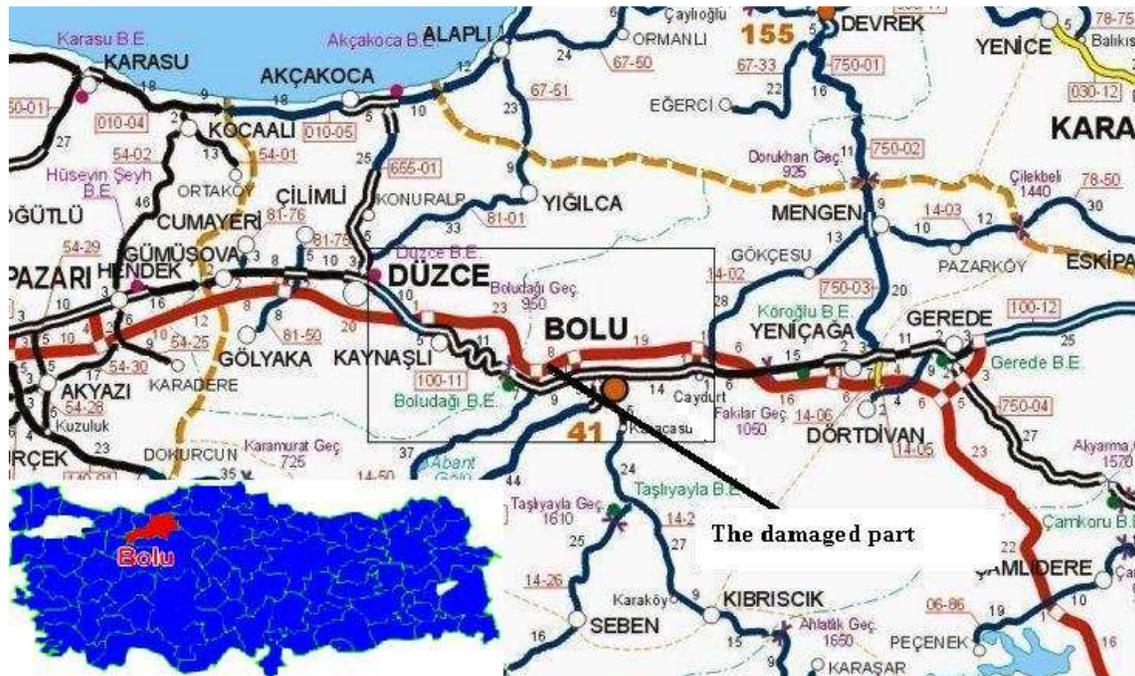
Figure 2 - Location and the damaged part of the Bolu Mountain Project

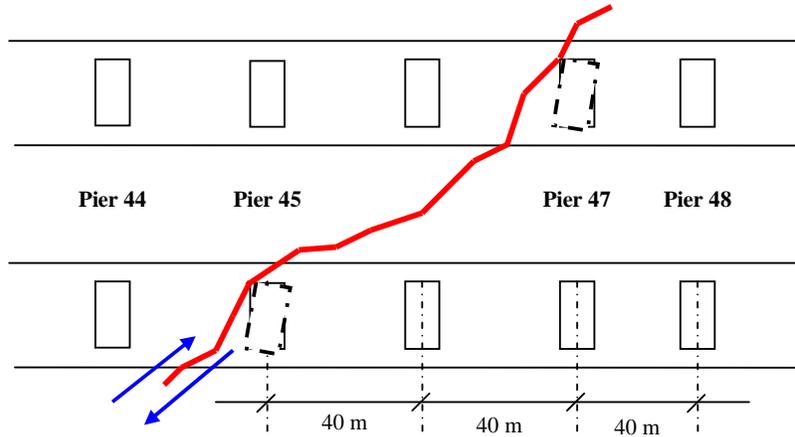
As is mentioned above, there is no alternative to examine the viaduct previous position within a global system, since the viaducts have been seriously damaged by 3 individual cracks of the North Anatolian Fault. Therefore, the damages on the viaduct piers and stretch have been investigated in two parts. First part is, from Düzce to Bolu direction up to crossing crack and

the second part is from Bolu to Düzce up to crossing crack. The fault trace at viaduct is demonstrated detailed in Figure 5.

Figure 5 - Fault trace at viaduct (Celik et al. 2005)

The viaduct region is divided into two parts near by pier 47. Therefore, analyses from two directions have been examined up to pier 48 from Düzce and up to pier 46 from Bolu. The overlapping region has been evaluated to see the effects of regional passing.

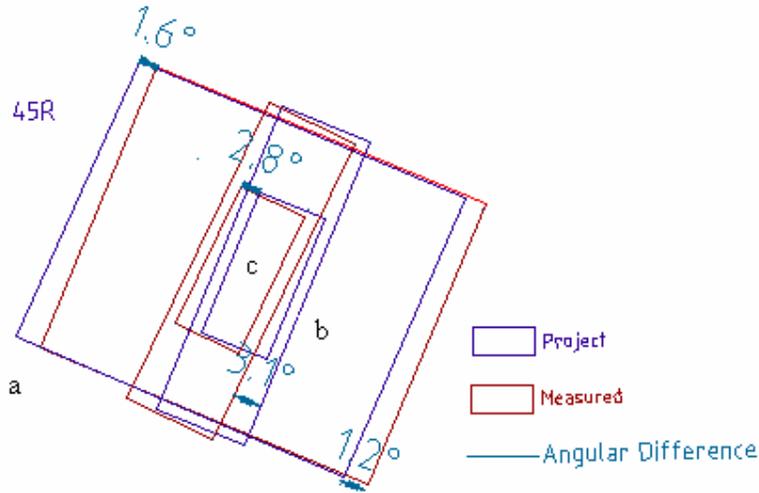
The rotations in the viaduct are obtained by calculating the differences between the azimuths calculated according to a reference coordinate (Tekdal, 2007). In the figures below 'a' represents the ground block on the pier, 'b' represents the upper block and finally 'c' represents the column. As seen in Figure 6 there is an approximately 3° rotation in pier 45R.

Figure 6 - The angular displacements in pier 45R (Tekdal, 2007)

In order to say there is torsion, the bottom and the upper part of the structures of the piers should perform different rotation angles at the same time. If we look at piers 45R in Figure 6 and 47L in Figure 8, lower and upper part has a different rotation value. So it can be said that the piers 45R and 47L has performed torsion (Tekdal, 2007).

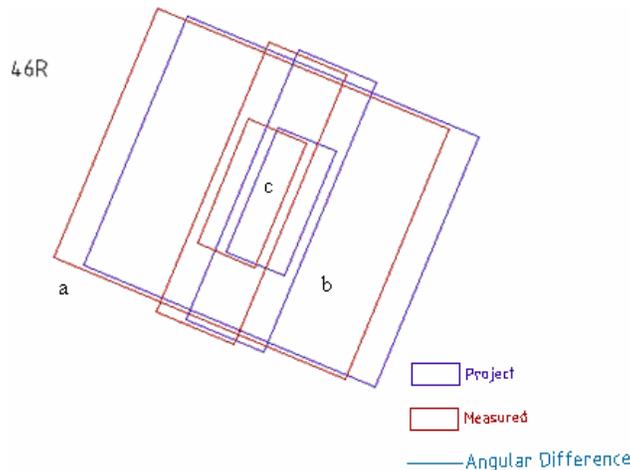
It is clearly seen in Figure 7 that the pier 46R did not performed a rotation, just moved parallel compared to the position before the earthquake.

Figure 7 - The angular displacements in pier 46R

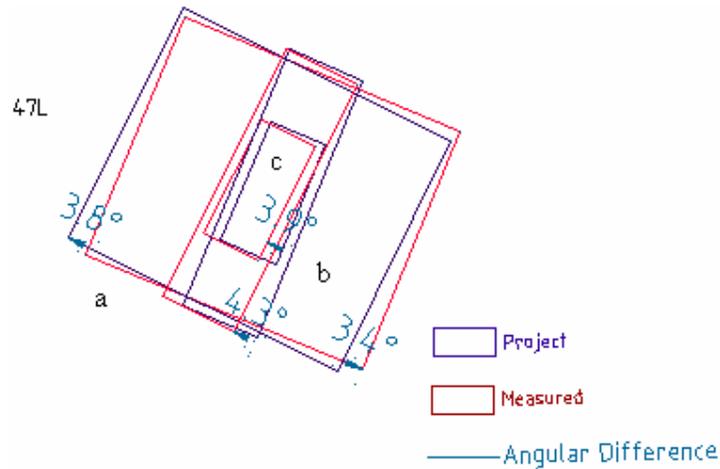
An approximate 4° of rotation achieved by pier 47L can be seen in Figure 8.

Figure 8 - The angular displacements in pier 47L
