Low cost UAV and image classification for monitoring the deterioration on building façades

Andrea Masiero¹, Francesca Fissore¹, Antonio Vettore¹

¹Interdepartmental Research Center of Geomatics (CIRGEO), University of Padua, Viale dell'Università 16, Legnaro (PD) 35020, Italy, (masiero@dei.unipd.it, francesca.fissore@unipd.it, antonio.vettore@unipd.it)

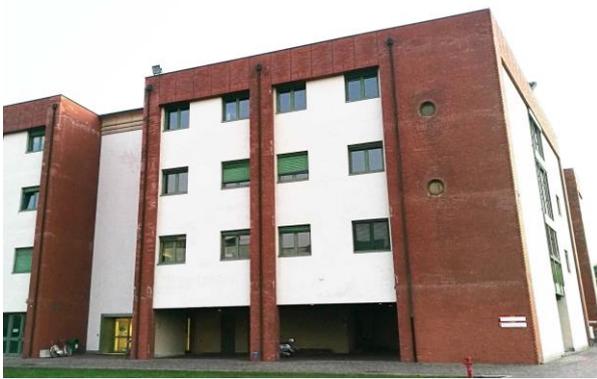
Figure 1. North-East façade of the considered building.

The case study considered in this paper is the detection of damaged bricks on a façade of the building of the University of Padua (Italy) shown in Fig. 1.

Such work has been motivated by the periodical need of maintenance for the façades of such building, which are subject to significant deterioration, in particular due to infiltration and weathering.

This paper presented the use of a deep learning-based method in order to detect damaged bricks on a building façade (the building of the University of Padua used as case study in this work is shown in Figure 1). The proposed approach, which exploited a very commonly used neural network properly re-trained with a relatively small training dataset, confirmed the high potential of such kind of approach in this application as well.

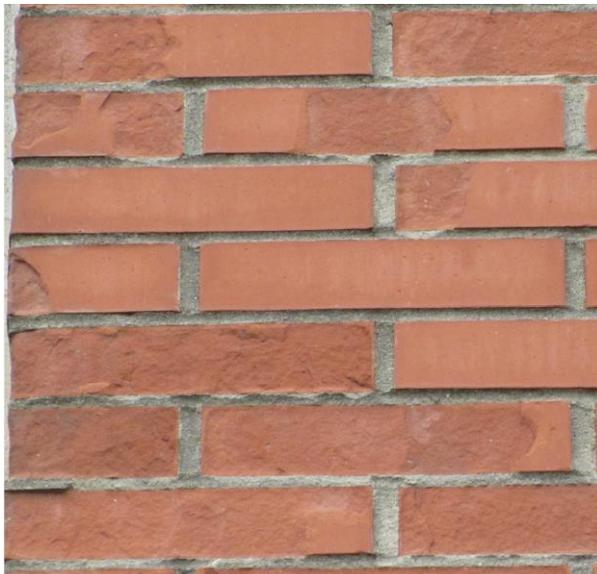
Fig. 2 shows a portion of the building façade, where several damaged bricks can be seen.

Figure 2. Portion of a façade of the building shown in Figure 1.

between the image detail shown in Fig. 2 (acquired at ground level by a professional digital camera) and the portion of the Bebop 2 image shown in Fig. 3. Nevertheless, the results shown in the following Section experimentally prove that the considered approach allows to obtain reasonable results even with such low cost drone and camera.

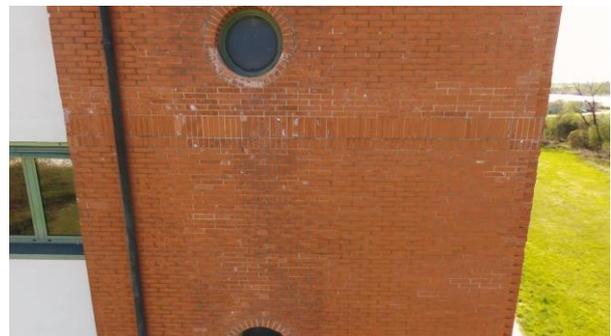
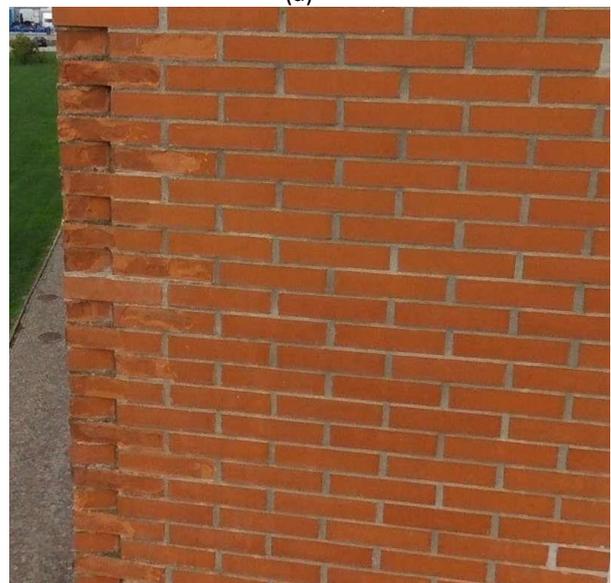
Despite the data acquisition has been done in video mode, the quality of images acquired by the drone is relatively good, in particular in slowly moving (quasi-still) conditions, as shown in Fig. 3.

Figure 3. (a) Example of Parrot Bebop 2 view at approximately 3-4 m far from the façade. (b) Portion of the façade extracted by a Parrot Bebop 2 camera view at 1-2 m distance from the building.

Despite the Bebop 2 camera is relatively good for a low cost drone, it is quite clear the quality difference

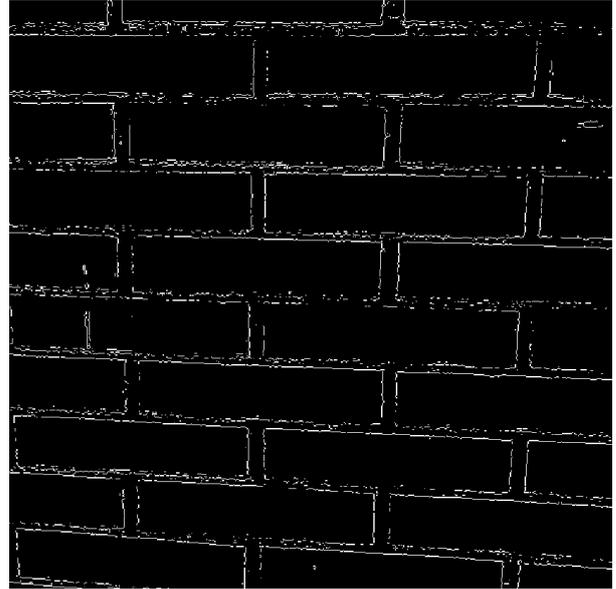
Figure 4 shows an example of Sobel filter result on a portion of a drone video frame.

Figure 4. Result of the Sobel filter on a portion of video frame acquired by the drone.

Edge detection is implemented by using a Sobel filter and then extracting the most probable lines by means of the Hough transform (Illingworth & Kittler, 1988; Kanopoulos, Vasanthavada, & Baker, 1988).

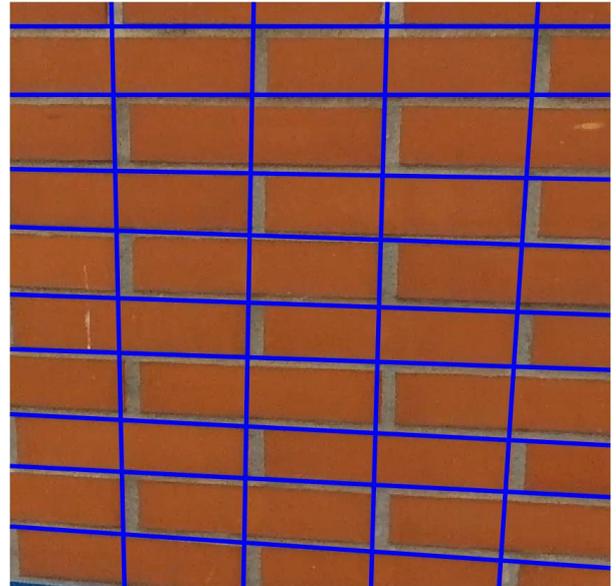
Figure 5. Lines detected with the Hough transform on the area shown in Figure 4.

The lines detected by means of the Hough transform in the image portion of Figure 4 are shown in Figure 5.

Hough transform requires a parametric representation of the lines to be detected. A standard line representation has been considered:

A discrete parametrization for θ and ρ in (1) has to be considered in order to apply the Hough transform. Angles have been sampled at a 1 degree resolution, whereas ρ has been sampled at a 1 pixel resolution.

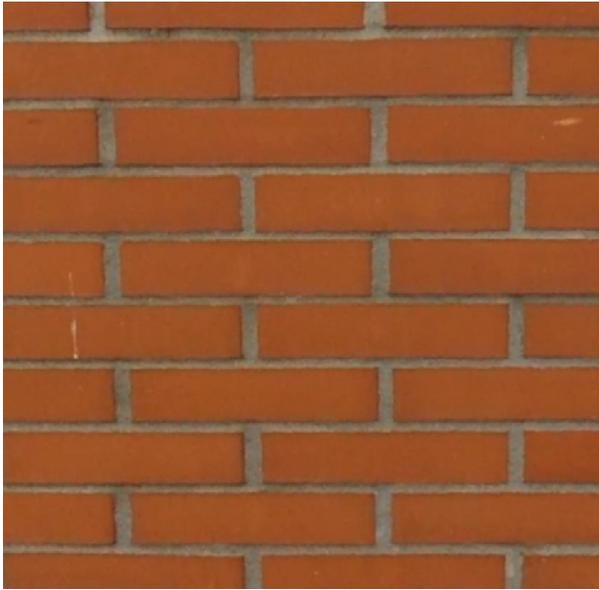
Once lines have been detected camera-wall relative orientation is estimated and corrected in order to have an approximately orthogonal camera view of the wall with the horizontal axis of the camera aligned with the horizontal brick borders: in such conditions the brick borders are approximately aligned with both the vertical and horizontal image axes (check an example of the obtained results in Figure 6). Such transformation is similar to the commonly used image rectification, i.e.

Figure 6. Remapped image.

$$\begin{bmatrix} u' \\ v' \\ 1 \end{bmatrix} \propto KR^TK^{-1} \begin{bmatrix} u \\ v \\ 1 \end{bmatrix} \quad (2)$$

where K = intrinsic camera matrix
 R = rotation matrix describing the camera-wall relative orientation

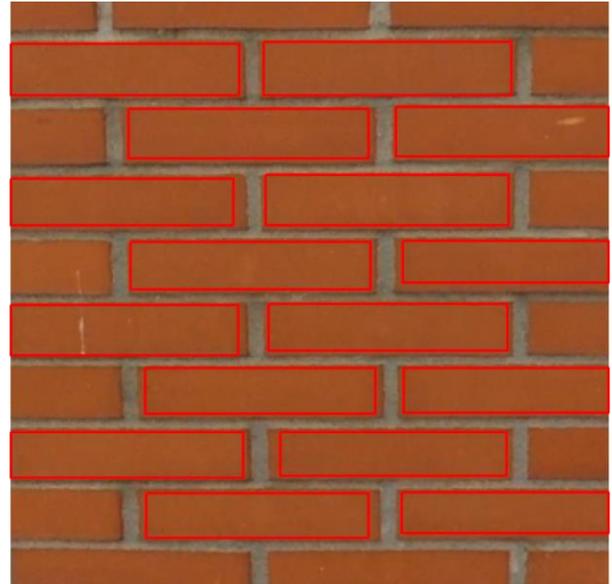
The result of such procedure applied to Figure 6 is shown in Figure 7.

Figure 7. Bricks segmented in Figure 6.

- Thresholding the image (e.g. by using Otsu's method)
- Finding the list of the connected regions in the thresholded image.
- For each connected region with a sufficient area (i.e. in order to consider only bricks which are entirely, or almost entirely, visible in such image) determining the smallest polygon (e.g. rectangle) containing such connected region.

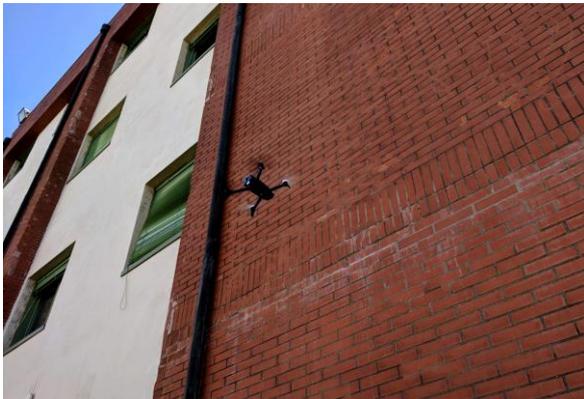
This paper aimed at showing the potential of even a very widely used network, such as the AlexNet, once properly re-trained in order to work on a very specific damage detection classification problem: to such aim, a very low cost drone has been used to acquire video frames of the façade of a university building. The drone flew at quite close distance from the façade, with the camera optical axis orientated approximately orthogonal to the façade surface (Figure 8).

Figure 7. Parrot Bebop 2 drone acquiring a video close to a façade of the building of Figure 1.

The drone flew at 1-2 m from the building façade during all the data acquisition. Camera and drone orientations were set in order to have an approximate frontal view of the façade.
