STRUCTURAL DEFORMATION MONITORING ANALYSIS USING GEODETIC TECHNIQUES AFTER THE EARTHQUAKE AT BOLU PASS OF TRANS-EUROPEAN MOTORWAY

Esra TEKDAL EMNİYETİ, Rahmi Nurhan CELİK and Tevfik AYAN

*Istanbul Technical University, Civil Engineering Faculty, Division of Geodesy, 34469 Maslak
Istanbul, Turkey*

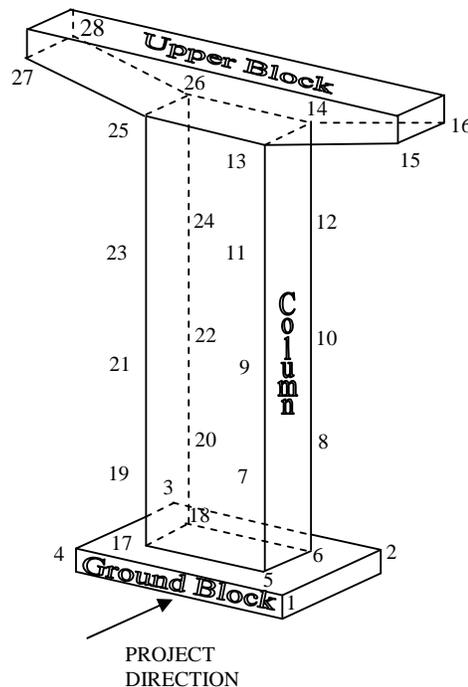
Figure 4 - Measured control points on the viaduct pier

Viaduct I measurements have been carried out using high-tech reflector-less total station. Using these total stations, detail points can be measured up to 100 meters without using a reflector. Therefore that technology provides speed and precision for such a difficult measurement. By using this technology, 28 detail points have been measured on each of the pier. Number of these points is more than sufficient amount to investigate the displacements of a pier. However in case of the measurement errors all available points on piers have been measured.

The final control is the bending check. To observe the bending in piers, upper and lower midpoints of piers are used. The lower and upper midpoint coordinates are calculated from the coordinates 1,2,3,4 and 13,14,25,26 respectively. The distance between project coordinates and measured coordinates are calculated (Tekdal, 2007). The results of these calculations can be seen in Table 5. According to the results, bending can be observed on piers 45R as 8 cm, 47R as 8 cm and finally 47L as 12 cm.

Deformations like rotation, bending and torsion in viaduct piers, especially the ones (45, 46, 47) located near the fault trace can be observed. Although the damages in piers are obvious it is advised to observe the critical piers by techniques other than the geodetic methods in detail.
